PERFORMANCE TEST REPORT

**PRODUCT TYPE: 3' x 8' Single Outswing Hardwood Door
with Side Lites and Half Circle Transom**

Report No.: 64142.01-801-44
Test Dates: 04/04/06
Through: 07/24/06
Report Date: 08/18/06
Expiration Date: 07/24/10

ASTM E 330-02, Test Method for Structural Performance of Exterior Windows, Curtain Walls and Doors by Uniform Static Air Pressure Difference

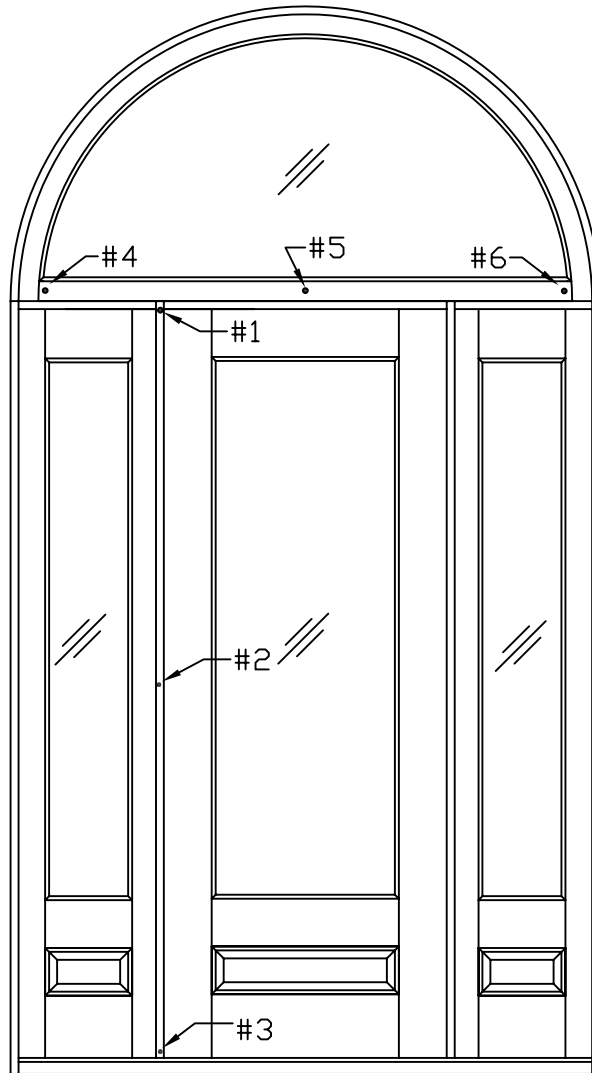
INDICATOR SKETCH

Note: See ATI Sketch #1 for indicator locations

<u>Indicator Number</u>			Net
	1	2	3	
Uniform Load Deflection per ASTM E 330 (Deflections were taken on the door)				
36.2 psf (positive) (load held for 30 seconds)	0.35"	0.71"	0.43"	0.32"
45.7 psf (negative) (load held for 27 seconds)	0.26"	0.67"	0.41"	0.34"

<u>Indicator Number</u>			Net
	4	5	6	
Uniform Load Deflection per ASTM E 330 (Deflections were taken on the transom sill)				
36.2 psf (positive) (load held for 30 seconds)	0.09"	0.16"	0.09"	0.07"
45.7 psf (negative) (load held for 27 seconds)	0.16"	0.22"	0.13"	0.08"

<u>Indicator Number</u>			Net
	1	2	3	
Uniform Load Structural per ASTM E 330 (Permanent sets were taken on the door)				
54.3 psf (positive) (load held for 10 seconds)	0.08"	0.08"	0.06"	0.01"
68.6 psf (negative) (load held for 10 seconds)	0.05"	0.05"	0.04"	<0.01"

<u>Indicator Number</u>			Net
	4	5	6	
Uniform Load Structural per ASTM E 330 (Permanent sets were taken on the door)				
54.3 psf (positive) (load held for 10 seconds)	0.02"	0.03"	<0.01"	0.02"
68.6 psf (negative) (load held for 10 seconds)	0.02"	0.02"	0.01"	<0.01"
